**Welded Continuous Frames & Their Components**

**Progress Report U**

**THE COLLAPSE STRENGTH OF A WELDED  
SINGLE BAY FRAME**

Fritz Laboratory Report No. 205D.5

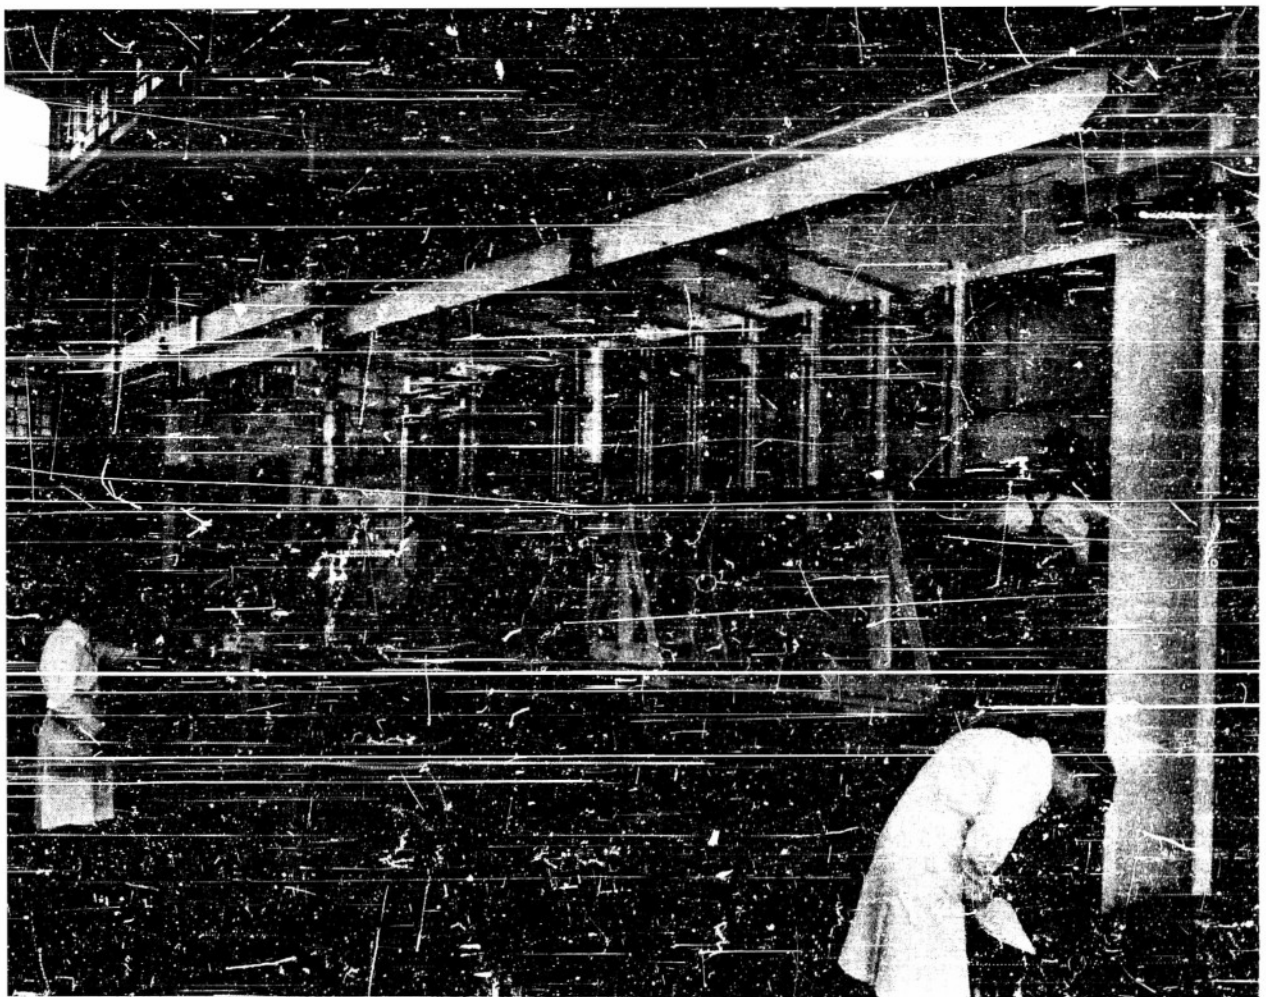
The lateral support system may be seen in the photograph of the general test arrangement shown in Fig. 2.

Measurements to determine the rotation occurring along a unit length of beam and across the knees of the frame were made by use of the rotation indicators described in Progress Report 7<sup>(2)</sup> and illustrated on Fig. 20 of that report. Four such rotation indicators were used on the present frame, one across each knee, one on the beam near the point where the second plastic hinge formed and one on the leeward column where the first plastic hinge formed. These indicators may be seen in the photographs of Fig. 2 and 3.

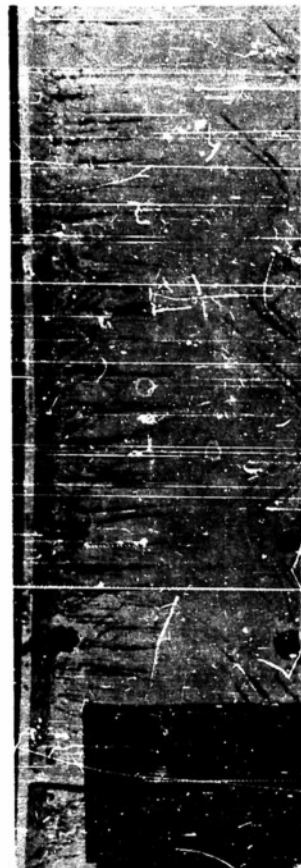
FIG. 13 REGION OF SECOND PLASTIC HINGE  
AT FINAL LOAD

The first evidence of instability was observed by eye after the ultimate load had been reached and took the form of a lateral displacement of the compression flange of the beam near the second plastic hinge. The effect of this lateral buckle has already been discussed with regard to the drop in moment capacity of the beam in the region where the buckle occurred. This buckle took the form of a wave about 3 ft. long, but its displacement was prevented from increasing by the lateral supports which were attached to the beam at the intersection of web and flange.

a. VIEW LOOKING UP

b. SIDE VIEW
